Philippine Electricity Market Corporation

SECOND METERING ARRANGEMENTS REVIEW

SUMMARY REPORT

April 2016

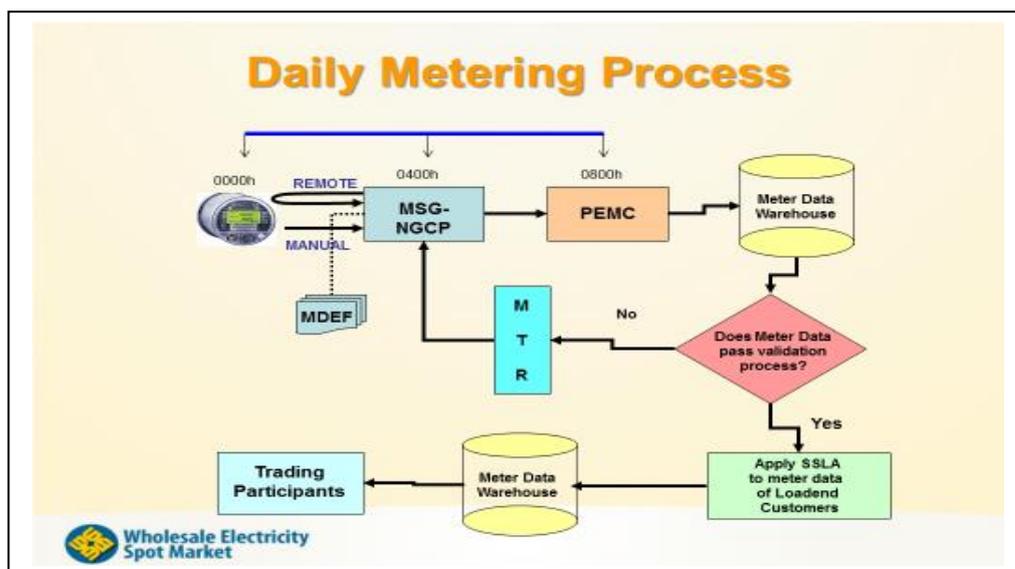
Figure 2-1: Daily metering Process in the WESM

The metering arrangements and data processing around metering are broadly similar for both WESM and RCOA, apart from differences in file transfer protocols and some additional processing to allocate loss adjustments to RCOA customers. Below is a brief description of the processes carried out every day for WESM meters. This provides some context for the scope of the review.

The WESM metering process illustrated is conducted daily. A monthly process is conducted prior to settlement for the full month of meter readings, to confirm completeness and accuracy of the monthly data used for settlement. The process for RCOA meters is similar, but with some differences in detail.

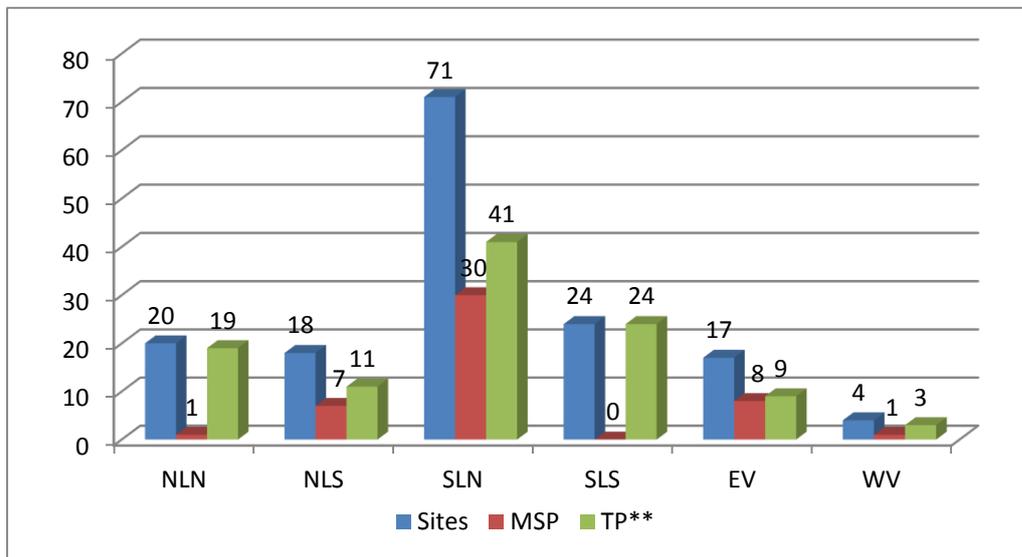
Figure 3-1: WESM Metering Facility Ownership

The chart following shows the number of metering sites audited in each of the NGCP MTDs listed above. Note that in 69% of sites, the instrument transformers are owned by the Trading Participant (TP).

** Instrument transformers are owned by the Trading Participant (TP)

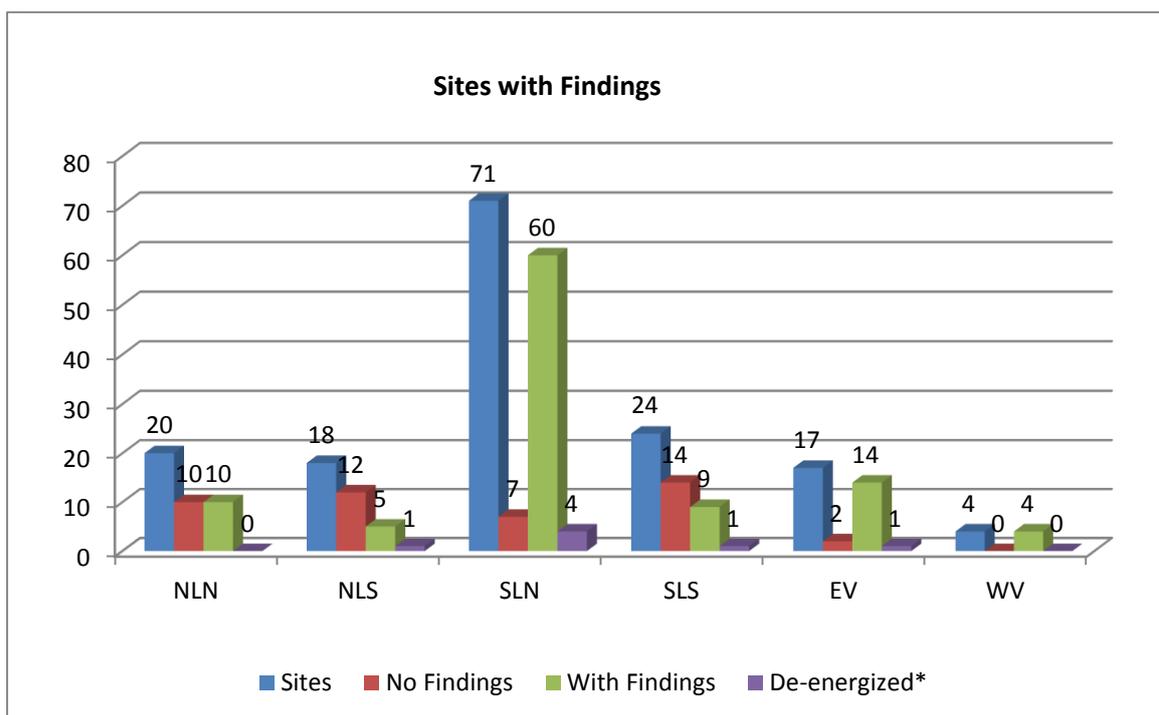
Figure 5-1: Findings on WESM Metering Sites by MTD - NGCP

The following figure and table summarise the number WESM sites with findings, classified by NGCP MTD and also by facility ownership. Some sites have multiple findings against different WESM Rules. The sites of MTDs SLN, EV and WV have findings well in excess of 50% of all their sites. MTD SLN stands out in terms of absolute numbers, with slightly less than half of the total findings. MSP and TP-owned facilities have, in total, similar proportions of sites with findings – around 70%.

Sites with Findings	By MTD							By Ownership		
	NLN	NLS	SLN	SLS	EV	WV	TOTAL	MSP	TP	TOTAL
Count										
Sites	20	18	71	24	17	4	154	47	107	154
No Findings	10	12	7	14	2	0	45	9	36	45
With Findings	10	5	60	9	14	4	102	33	69	102
De-energized*	0	1	4	1	1	0	7	5	2	7

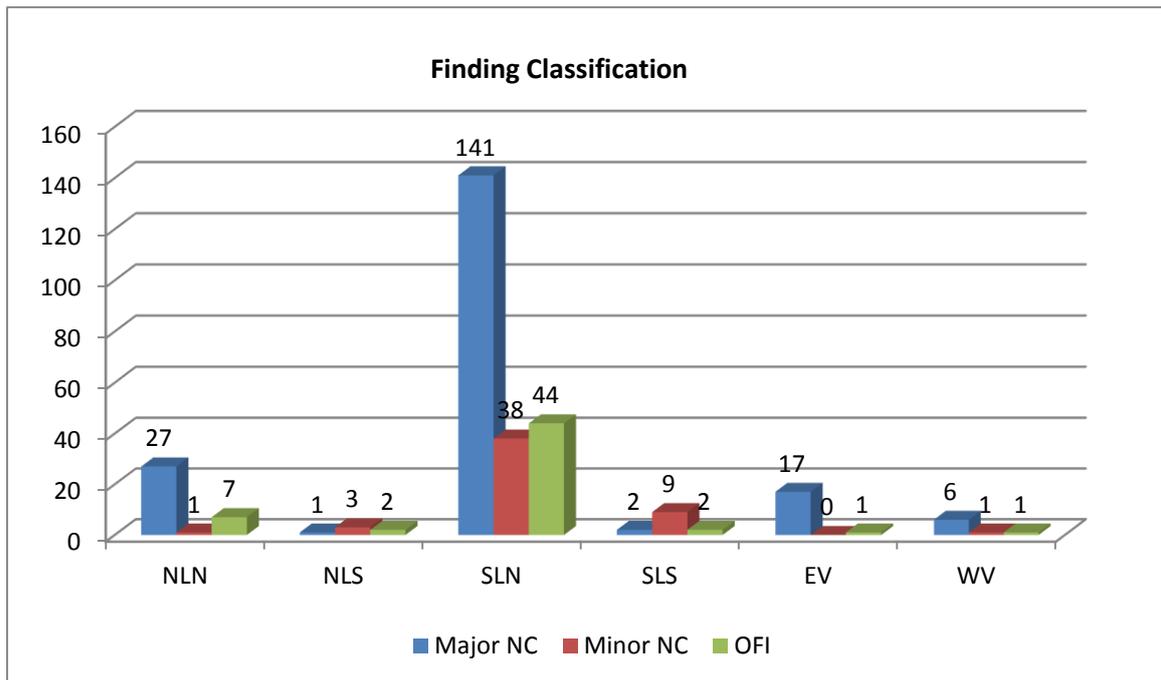
Figure 5-2: Findings on WESM Metering Sites by Classification - NGCP

The standout observation is the high number of findings on SLN, especially in the Major category. While SLN has more meters than other MTDs, the proportion of findings at SLN is also high relative to other MTDs. This observation together with observations on process control suggests a regional management problem at SLN that NGCP management needs to correct.

Classification	By MTD							By Ownership		
	NLN	NLS	SLN	SLS	EV	WV	TOTAL	MSP	TP	TOTAL
Major NC	27	1	141	2	17	6	194	69	125	194
Minor NC	1	3	38	9	0	1	52	10	42	52
OFI	7	2	44	2	1	1	57	26	31	57
Totals	35	6	223	13	18	8	303	105	198	303

The table on the following page breaks down the Major non-conformances according to the Rule violated, separated by MTD and also by facility ownership. The highest number of non-conformances relates to security issues and there is a concentration of security-related findings in SLN MTD as well as in TP-owned facilities. The review recommends a tighter compliance enforcement regime for TP-owned facilities. More detail on each Major findings is given in Appendix B.
